Thermal Nondestructive Evaluation Report Inspection of the Refurbished Manipulator Arm System in the Manipulator Development Facility at Johnson Space Center 10-12 January 2001

K. Elliott Cramer
NASA Langley Research Center
4 Langley Blvd. – MS231
Hampton, VA 23681
(757) 864-7945
k.e.cramer@larc.nasa.gov

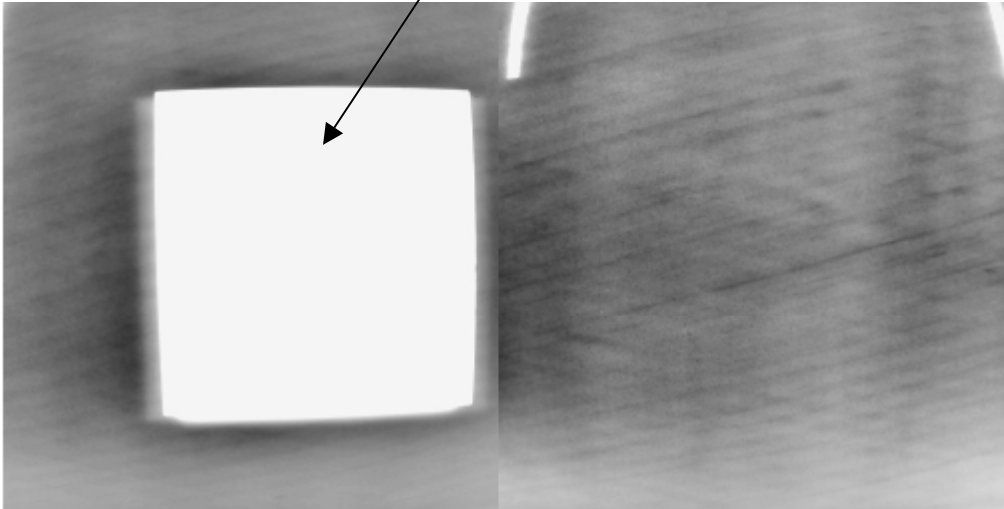
No indications of material degradation were recorded in the thermal inspection. Note that the fiber lay-up is clearly visible in this image.

Location #1
No Indications Recorded

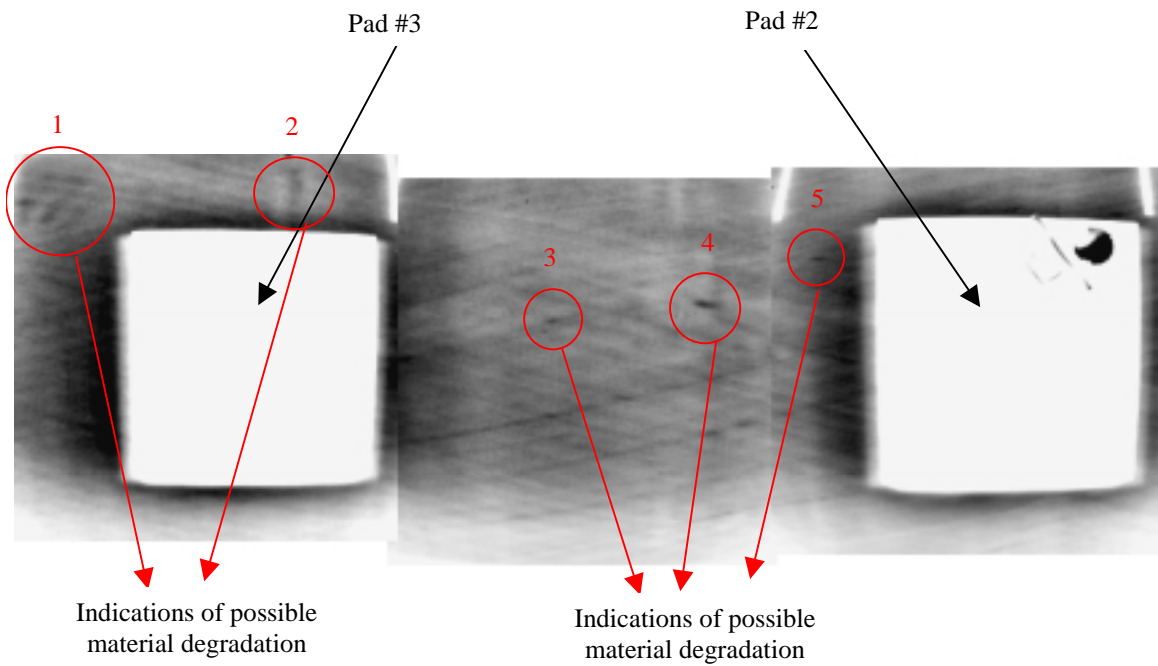
Location #2

Several small indications were recorded, especially between pad #2 and pad #3. These indications are consistent with a reduction in thermal

heat flow into the material, which could be due to a number of factors such as porosity, resin rich regions or localized delaminations[#].

The two indications above pad #3 are also consistent with a reduction in thermal heat flow, but are of a larger extent. The time resolved data reveals that these indications appear to be limited in extent to very close to the surface.

#1 – 1.4 in. wide x 1.1 in. high

#2 – 0.9 in. wide x 0.8 in. high

#3 – 0.3 in. long

#4 – 0.4 in. long

#5 – 0.35 in. long

[#] Note: These small indications are seen throughout the upper and lower arm, even in areas where no impact is suspected, which may indicate that they are a result of the manufacture of the structure.

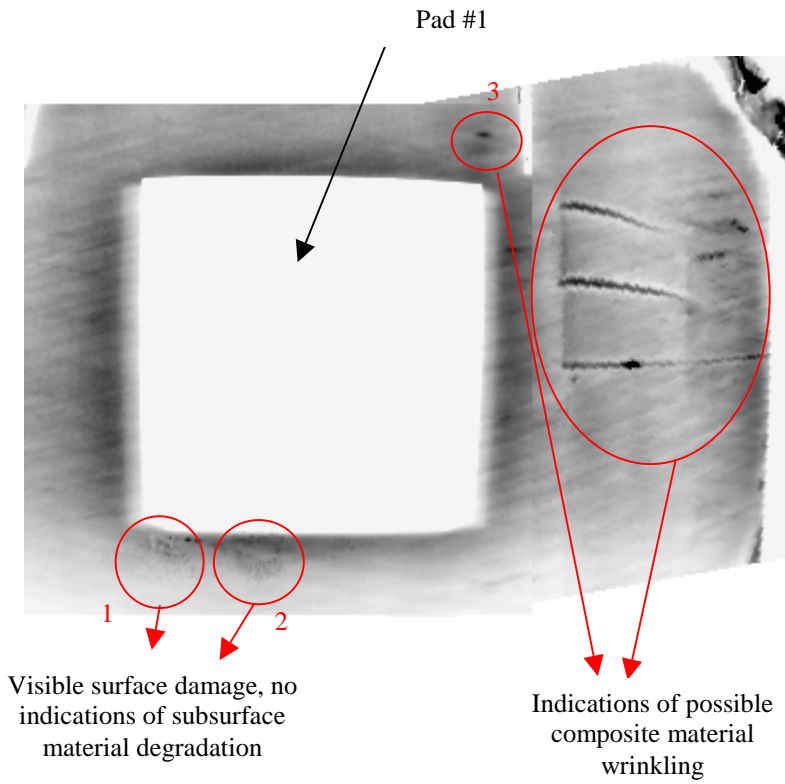
Location #3

Directly below pad #1 the visible surface damage can also be seen in the IR images. This damage appears to be limited in extent to the near surface region and does not display thermal characteristics of impact damage that has resulted in subsurface delaminations.

Between pad #1 and the elbow indications were observed which are consistent with wrinkles in the composite material.

Additionally, just above the right corner of pad #1 is a small indication[#] consistent with those seen throughout both the upper and lower arms (see note on location #2).

#1 – 0.9 in. wide x 0.6 in. high

#2 – 0.8 in. wide x 0.7 in. high

#3 – 0.32 in. long

Note: It was not possible to make measurements of the size of the wrinkles because of the large camera angle required to access this location.

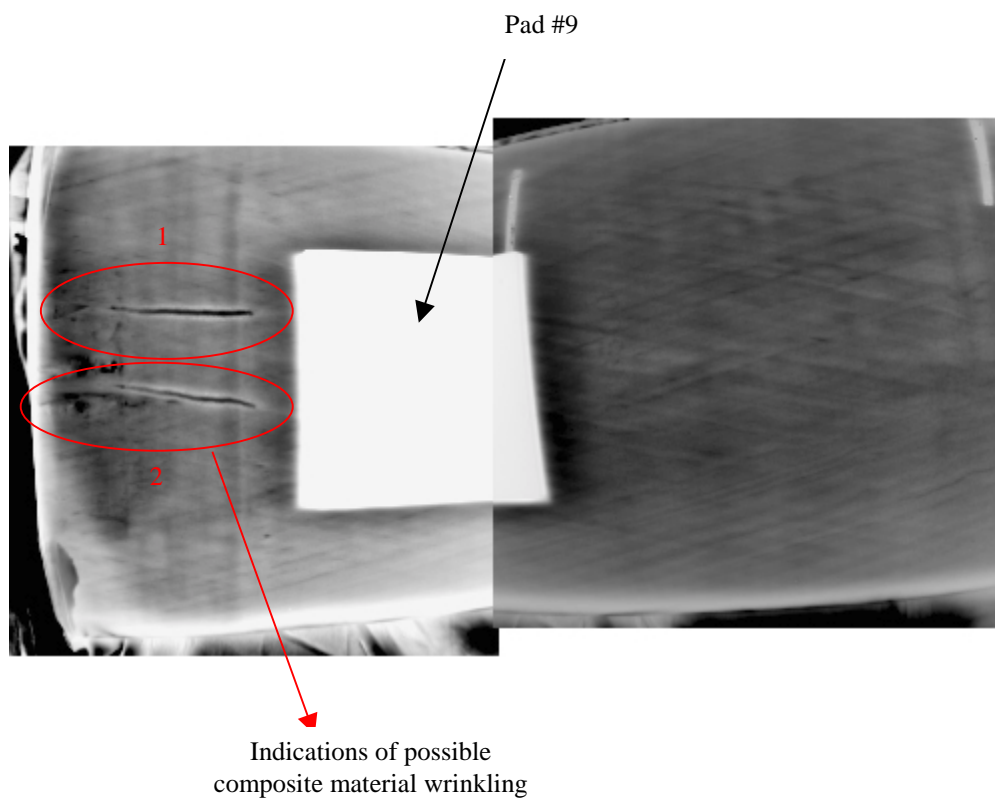
Location #7

Between pad #9 and the shoulder indications were observed which are consistent with wrinkles in the composite material as seen in Location #3.

#1 – 2.8 in. long

#2 – 3.8 in. long

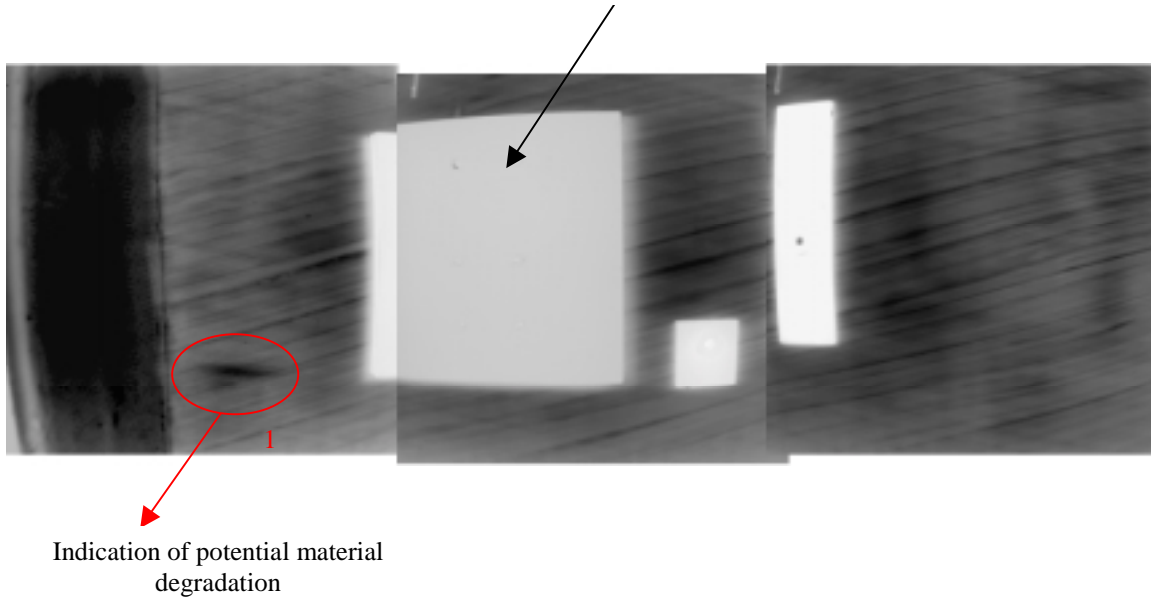
Location #4

One indication was recorded between pad #10 and the elbow. This indication (although larger) is consistent with the small indications[#] seen throughout both arms (see note on location #2).

#1 – 1.35 in. wide x 0.3 in. high

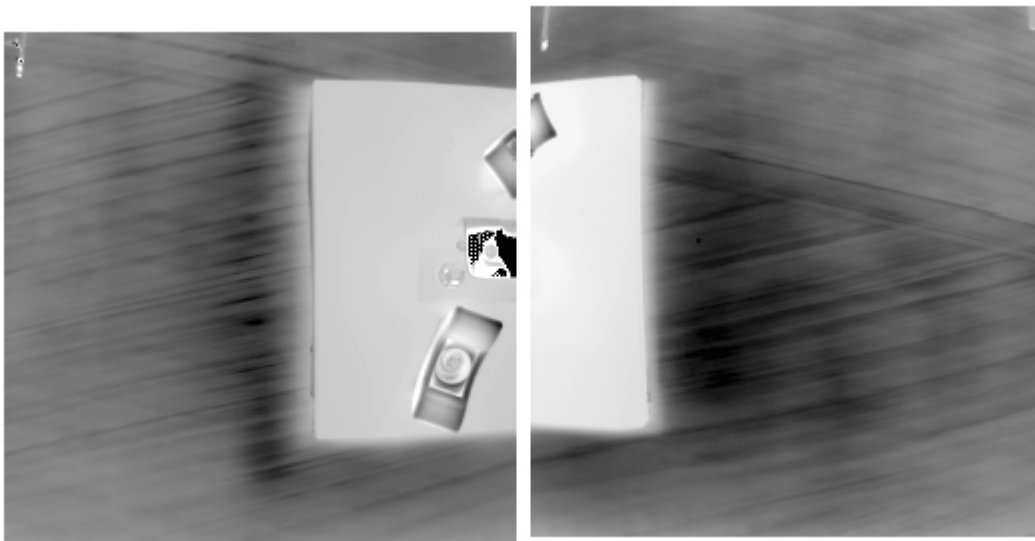
Pad #9

No Indications (Recorded for Reference)

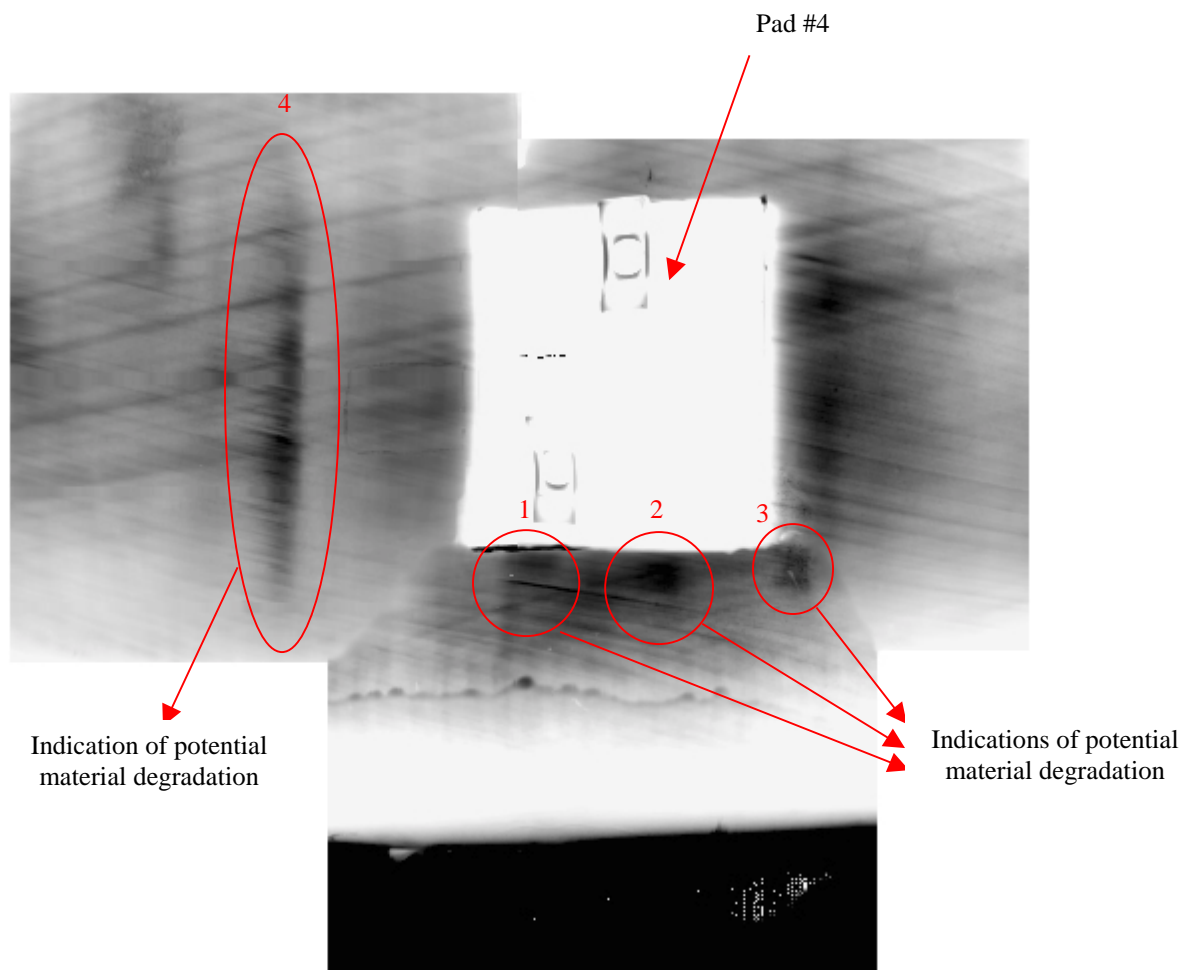
Locations #5 & #9

A number of significant indications were observed in these locations. First, a large vertical indication parallel and to the left of pad #4 was observed. This indication appears to extend quite deep into the material (at least through ½ the thickness) and also tends to spread parallel to the fibers. Again this is a region that does not allow good propagation of the heat flux and could be attributed to porosity, dry fibers (resin poor regions) or delaminations.

Another series of indications were recorded directly below pad #4. These indications do not appear to follow the fiber layup and also extend quite deep into the material.

#1 – 0.8 in. wide x 0.5 in. high

#2 – 0.8 in. wide x 0.6 in. high

#3 – 0.5 in. wide x 0.8 in. high

#4 – 0.8 in. wide x 6.25 in. high

Certain areas (Locations 5, 8 and 9) showed indications unique enough to warrant further investigation of these with other techniques such as conventional and advanced ultrasound or x-ray.

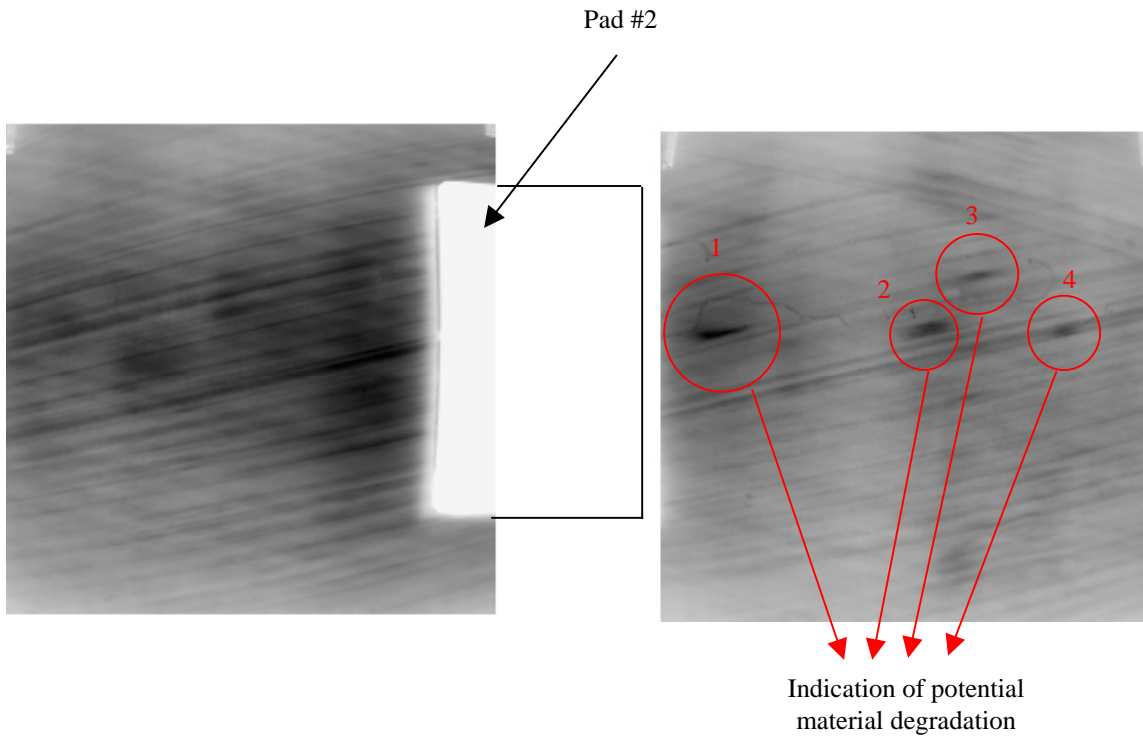
Location #6

Four indications were recorded between pad #2 and pad #1. These indications are consistent with the small indications[#] seen throughout both arms (see note on location #2).

#1 – 1.7 in. wide x 0.3 in. high

#2 – 0.8 in. wide x 0.3 in. high

#3 – 0.8 in. wide x 0.2 in. high

#4 – 0.4 in. wide x 0.3 in. high

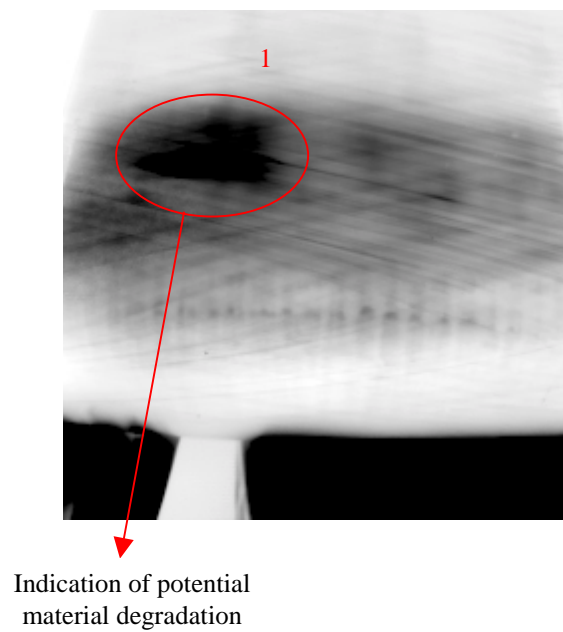
Location #8

Between pads #7 & #8 a single indication was observed which is consistent with impact damage indications that have been observed in other composite materials. This indication is fairly localized on near the surface, but appears to grow in size deeper into the material.

#1 – 2.2 in. wide x 0.6 in. high
